Energy & Green Building

Restoration puts firm at head of the class

Seaboard Restoration has given New York's very first 'green building' a face lift.

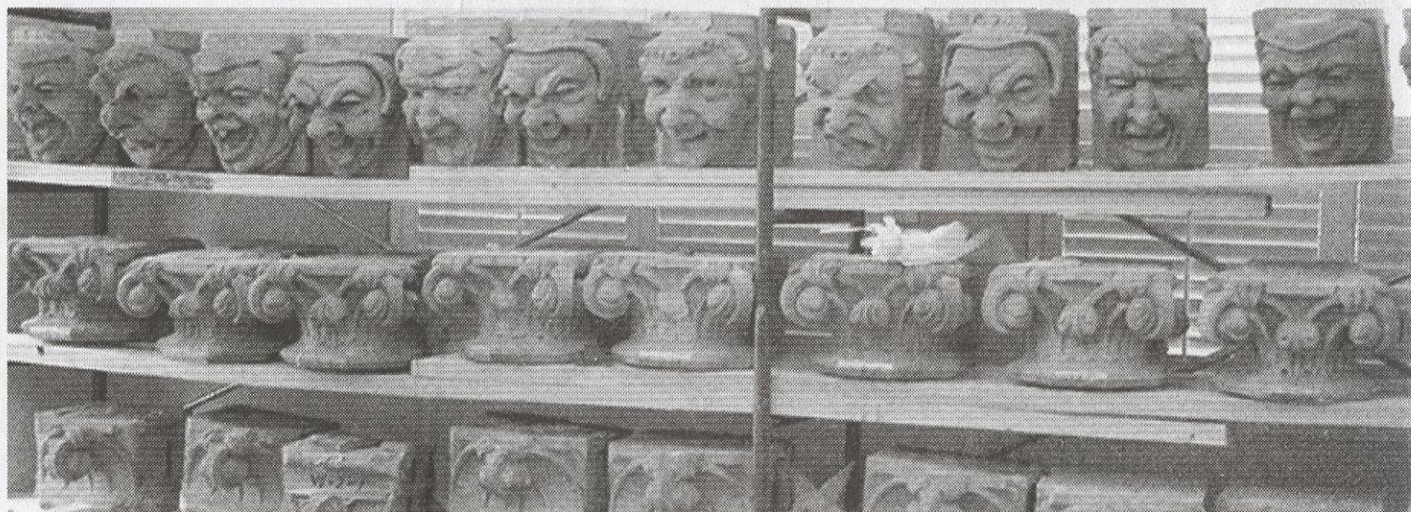
The Seaboard Restoration team (above) repaired almost all of the 94 terra cotta heads on the building — many representing political figures of the time — and replaced them individually.

The walls were rebuilt along with additional tiebacks and reinforcements to better protect the integrity of the building. The team also determined that almost all of the 94 terra cotta heads — many representing political figures of the time — were crumbling or broken, had suffered internal damage, and required repair.

Approximately 900 pieces of terra cotta were tagged, removed, catalogued, organized, cleaned, and repaired mostly in the basement of the building. They then were reinstalled in their original locations on the building's two street-front facades.

Several hundred additional pieces were repaired in place. Terra cotta bricks were salvaged wherever possible and new glazed bricks were ordered to best match the color, shape,
